# Manhole Inspection Summary

Manhole # S47CC\_021MH

Insp Date: **7/22/08 8:28 AM**

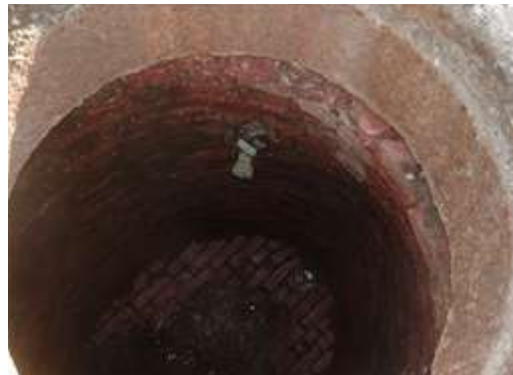
Defect 1

Infiltration: ☐ None ☐ Joint ☐ Cracks ☐ Mortar ☐ Roots ☒ **Wall**

infiltration

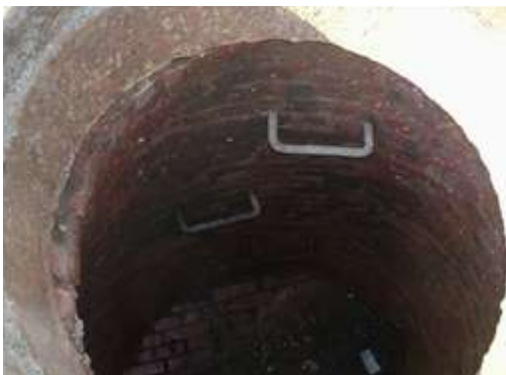
Defect 2

☒ **Leaks**

frame leaks

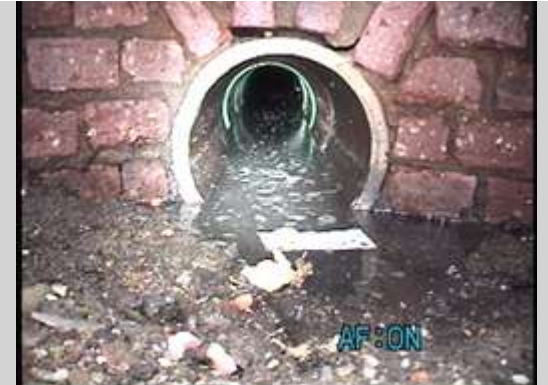
12 O'Clock Outflow

8 in. Circular Gravity Sewer  
Pipe Out @ 12 O'Clock

Infiltration: **None** Pipe Seal Cond: **Sound**
